INDOOR AIR QUALITY ASSESSMENT

**Joseph P. DeMello Elementary School
654 Dartmouth Street
Dartmouth, Massachusetts**

Prepared by:
Massachusetts Department of Public Health
Bureau of Environmental Health Assessment
July, 2002

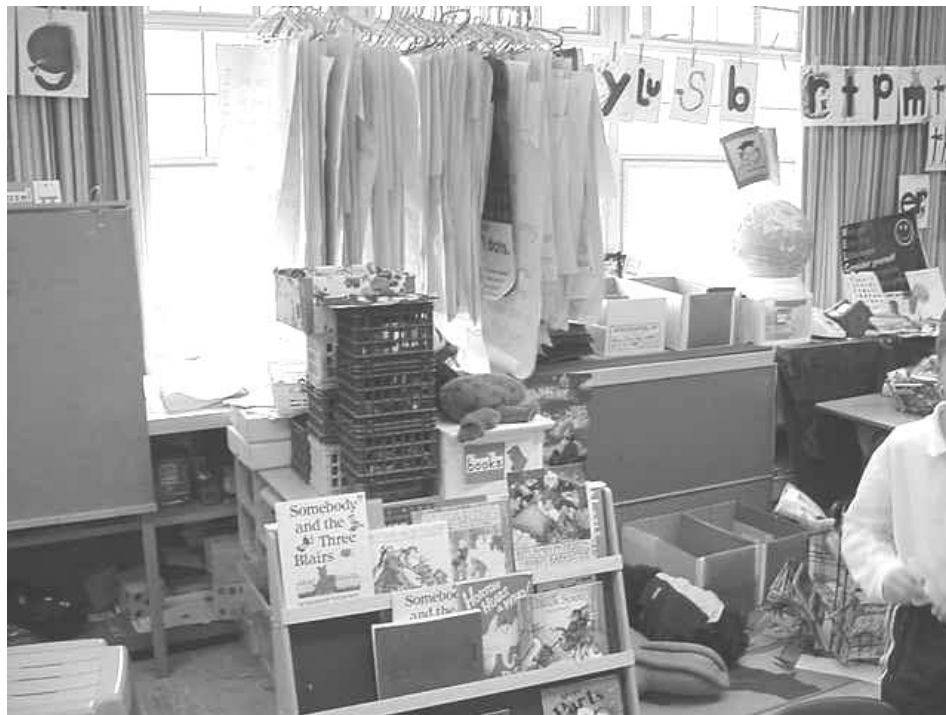
Picture 1

Univents were operating in all of the areas surveyed (see Tables). Obstructions to airflow, such as books, papers and posters on top of univents, as well as desks and carts in front of univent return vents, were seen in a number of classrooms (see Picture 1). To function as designed, univent fresh air diffusers and return vents must remain free of obstructions.

Classroom Univent Obstructed by Various Items

4. Shorten flexible ductwork shown in Picture 2 to decrease angles and increase airflow.
 5. Remove all blockages from univents and exhaust vents to facilitate airflow. Consider removing coat closet doors to prevent blockage or re-locating passive door vents to the top of coat closet doors to improve exhaust ventilation.

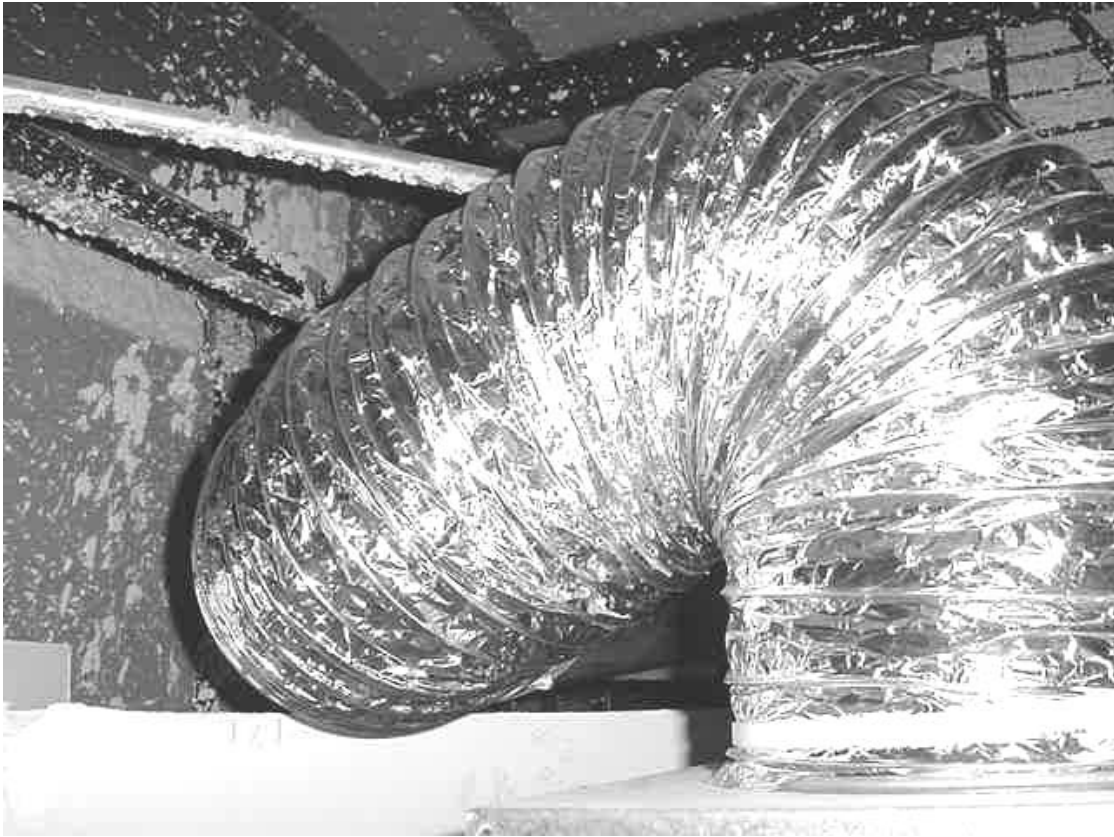
Picture 2

Exhaust vents in the 1966 addition are located in the ceilings of coat closets. Classroom air is drawn into the coat closet via an undercut below the closet door. This design allows for the vents to be easily blocked by stored materials. In a number of classrooms, these vents were blocked with books, book bags, boxes and other items. In order to function properly, these vents must remain free of obstructions. No draw was detected from the ceiling-mounted exhaust vent in the resource room near the library, which may indicate that the system was deactivated or that rooftop motors were not operating (see Picture 2).

Twisted Ductwork above Ceiling in Resource Room near Library

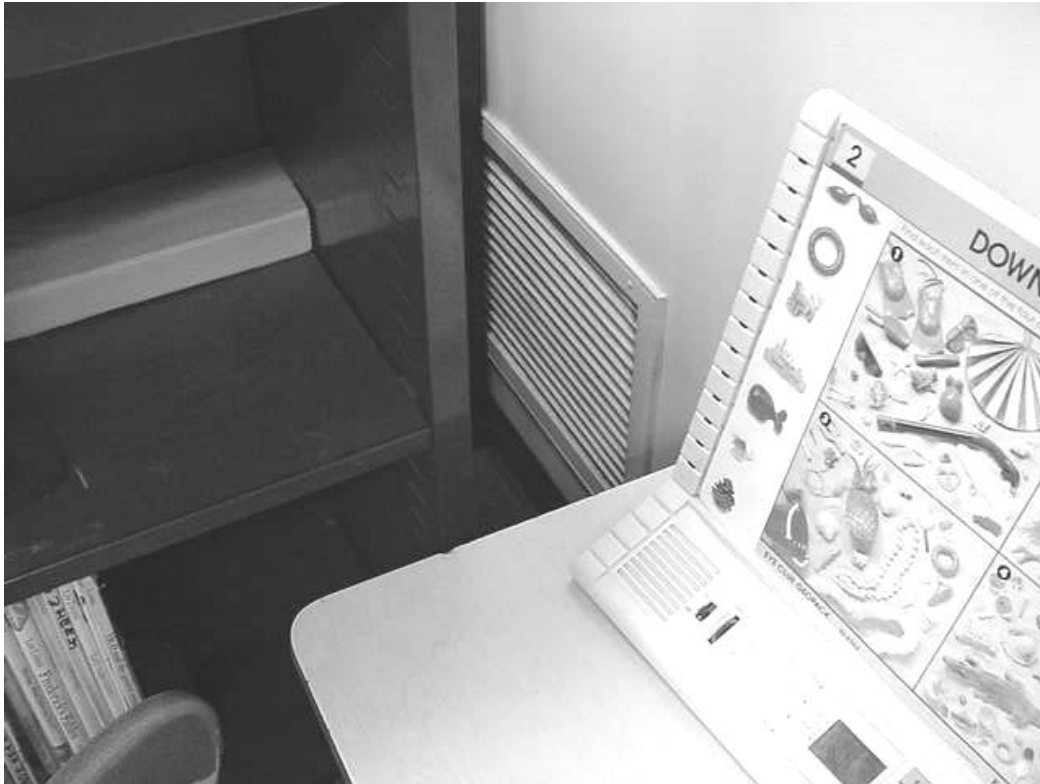
Picture 3

The mechanical exhaust ventilation system in the original building consists of wall-mounted vents. A number of these vents had little or no draw of air. As with the univents, a number of exhaust vents were obstructed by various items (see Picture 3). Without sufficient exhaust ventilation, normally occurring pollutants cannot be removed allowing them to build up and lead to indoor air quality/comfort complaints.

Partially Blocked Exhaust Vent in Classroom

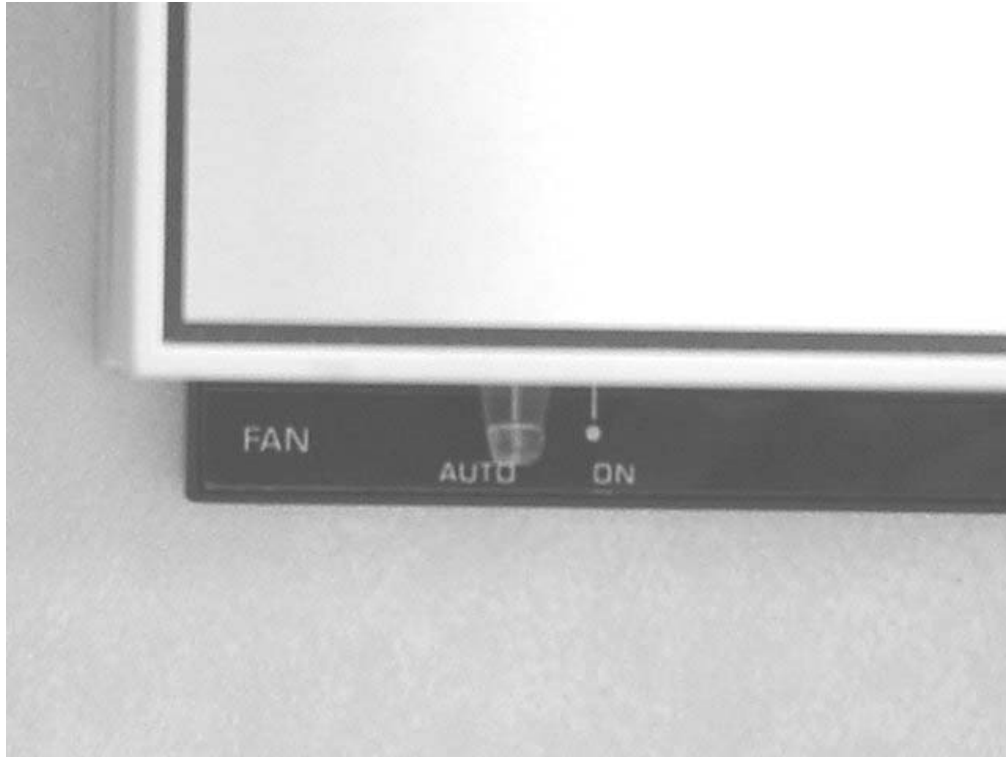
Picture 4

Ventilation for the portable classroom wing is provided by two air-handling units (AHUs) located on the exterior wall of the building. Fresh air is distributed to classrooms via ductwork connected to ceiling-mounted air diffusers. The amount of fresh air drawn into the units is controlled by moveable louvers connected to an activator motor that adjusts to alter fresh air intake to maintain temperature. Return vents draw air back to the units through wall or ceiling-mounted grilles. A thermostat controls the heating, ventilating and air conditioning (HVAC) system. The thermostat has fan settings of “on” and “automatic”. The thermostat was set to the “automatic” setting during the assessment (see Picture 4). The automatic setting on the thermostat activates the HVAC system at a preset temperature. Once a preset temperature is measured by the thermostat, the HVAC system is deactivated. Therefore no mechanical ventilation is provided until the thermostat re-activates the system.

Portable Classroom Thermostat Fan switch to "Auto"

1. To maximize air exchange, the BEHA recommends that both supply and exhaust ventilation operate continuously during periods of school occupancy independent of classroom thermostat control.
2. Examine each AHU (e.g., cafeteria) and univent and for proper function. Survey equipment to ascertain if an adequate air supply exists for each area serviced.

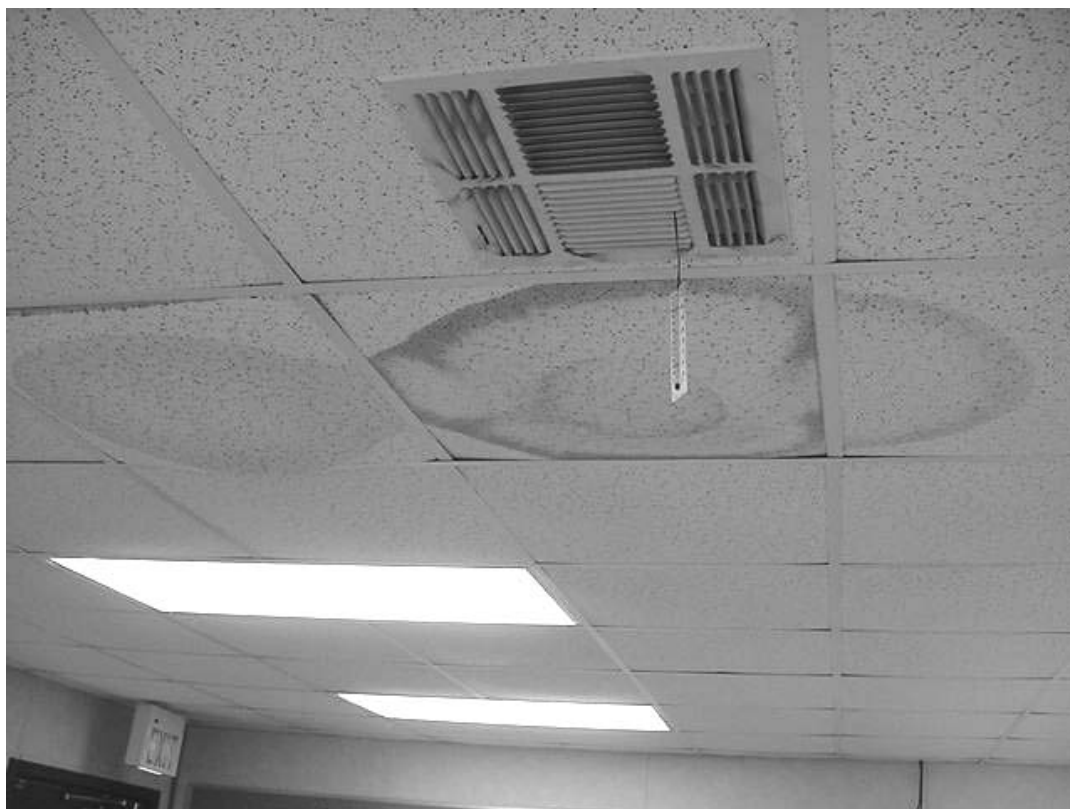
Picture 5

Water-damaged ceiling tiles were noted in the portable classroom (see Picture 5). If wetted repeatedly, porous materials can grow mold and be a source of unpleasant odors. Water-damaged building materials should be replaced after a water leak is discovered.

Water Damaged Ceiling Tiles in Portable Classroom

11. Repair any water leaks and replace any remaining water-stained or missing ceiling tiles. Examine the areas above and behind these tiles for mold growth. Disinfect areas of water leaks with an appropriate antimicrobial.

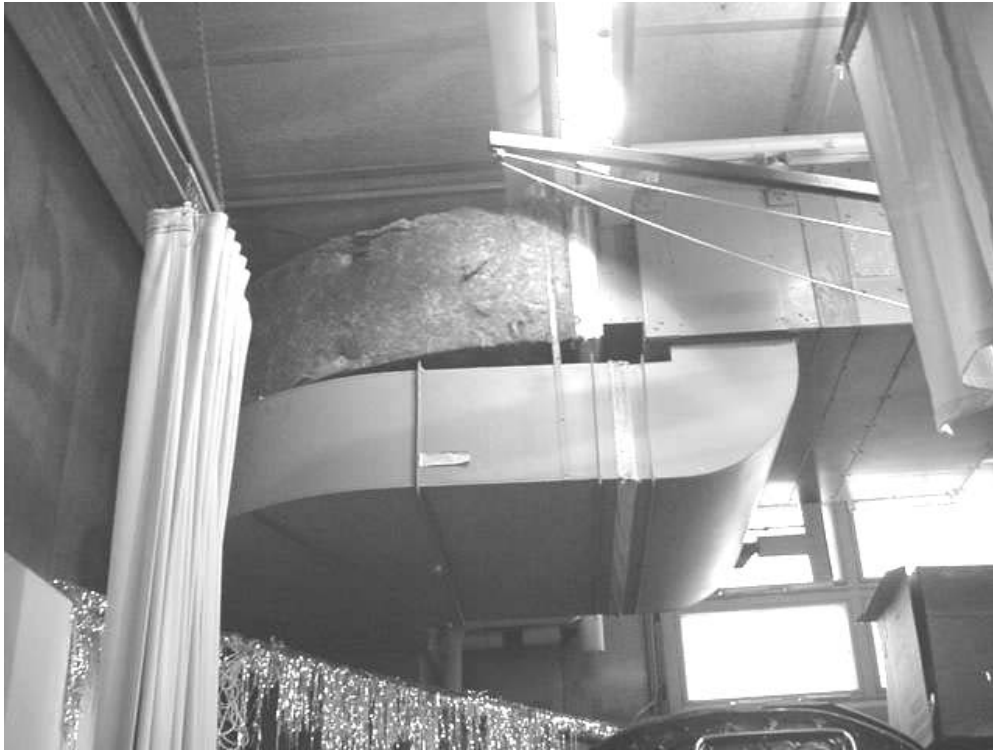
Picture 6

Several other conditions were noted during the assessment, which can affect indoor air quality. Exposed fiberglass was observed around the ductwork to the cafeteria

AHU (see Picture 6). Fiberglass can be an eye, skin and respiratory irritant to certain individuals.

Exposed Fiberglass Insulation in Cafeteria (Stage Area)

14. Encapsulate exposed fiberglass insulation in cafeteria.
15. Clean/change filters in air purifiers and portable air conditioners as per the manufacturer's instructions.

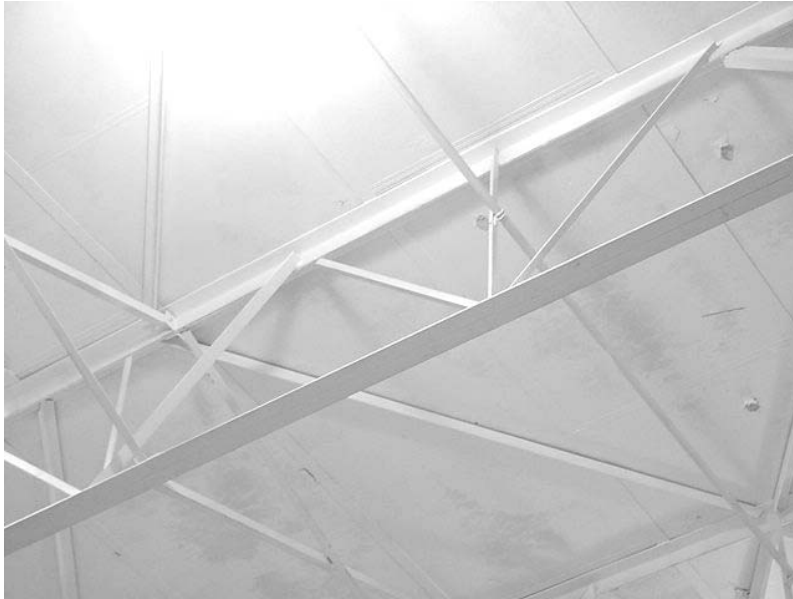
Picture 1

Action Taken: The DSD purchased a lift to conduct a thorough cleaning and disinfection of all ceiling tiles, roof supports and trusses as verified by BEHA staff (see Picture A-1). Supports and trusses were also repainted.

Gymnasium Ceiling and Support Trusses free of Accumulated Dust and Debris

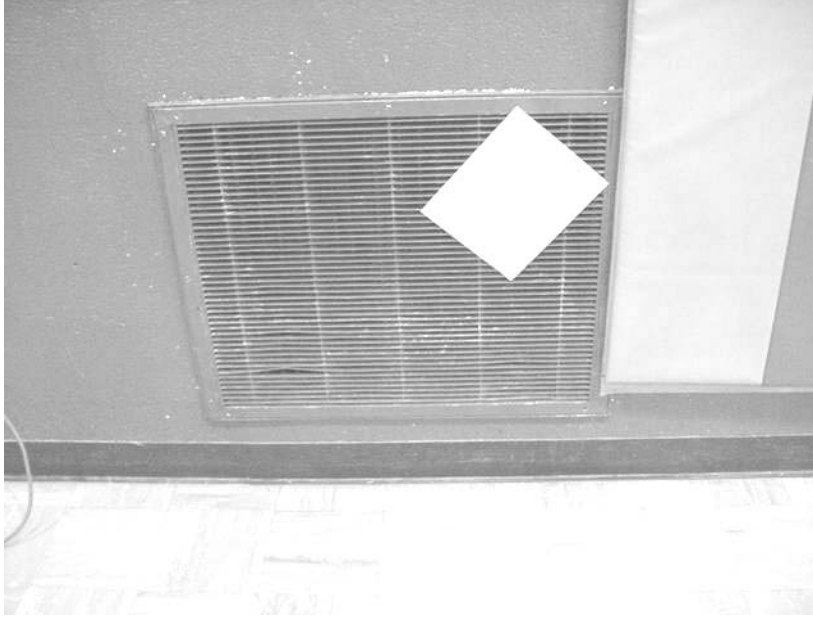
Picture 2

Action Taken: Mechanical components for the gymnasium ventilation system were reportedly repaired/replaced thereby greatly increasing air circulation (see Picture A-2).

**Return Vent for Gymnasium AHU, Exhaust Ventilation Capacity Greatly Increased, Note
Paper Being Drawn Into Vent**
